**CORNWALL TAILINGS DAM**

NDI NO. PA-00597

**PHASE I INSPECTION REPORT  
NATIONAL DAM INSPECTION PROGRAM**

JULY 1979

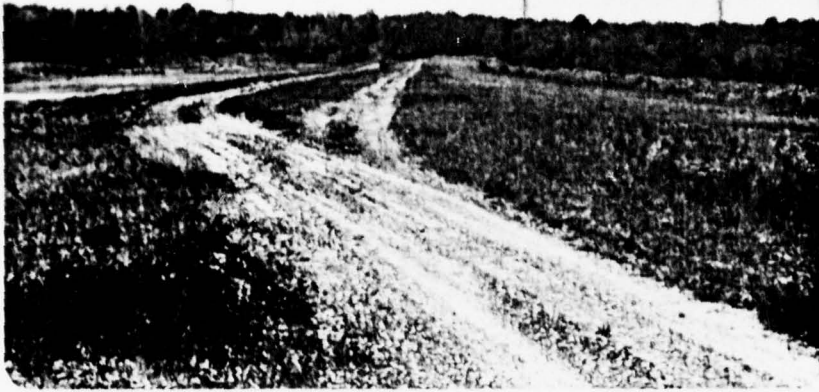
Top of Dam  
Looking to  
Left Abutment

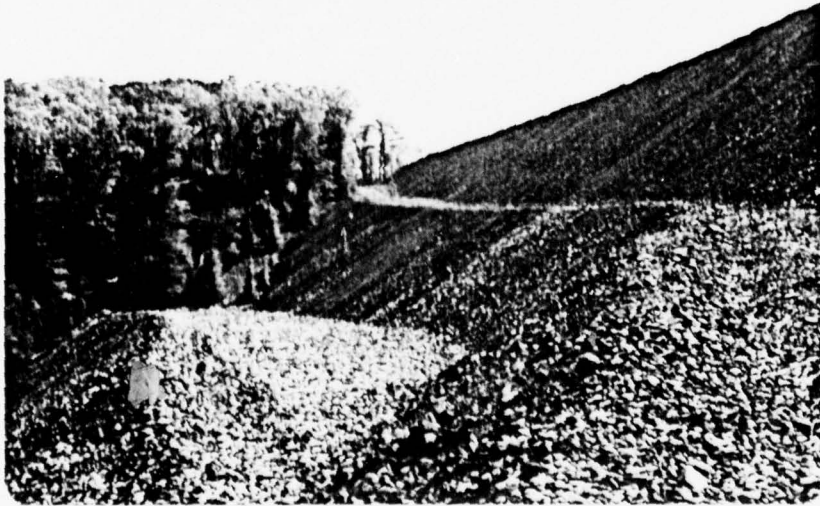
The visual inspection of the downstream slope did not reveal any evidence of instability. The rock slope surfaces appear to have stabilized with varying slope angles between the 1:1H to 1V and 1:7H to 1V range dependent upon the size of the rock and the amounts of fine stone in a particular area. When considering the dimensions of the entire downstream portion of the embankment, 395±H to 203±V, the benches do not appear to be significant in the evaluation of the slope stability. The overall top to toe slope is flatter than the recommended 1.75H to 1V. This fact, together with the observed conditions indicates that the embankment slopes are stable.

Downstream Slope

Formal maintenance procedures do not exist and are not required at the present time. Brush and tree growth should be prevented on the downstream slope, the crest and the upstream slope near the crest. It is recommended that a formal surveillance and downstream warning system be developed for implementation during periods of high or prolonged precipitation.

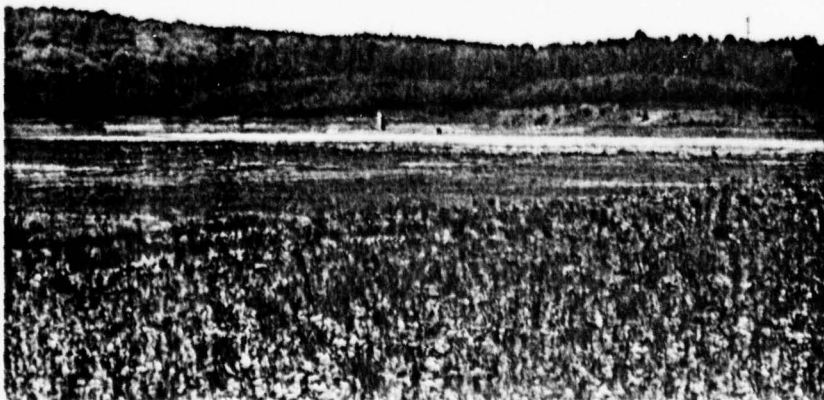
View from top of  
dam towards  
decant towers

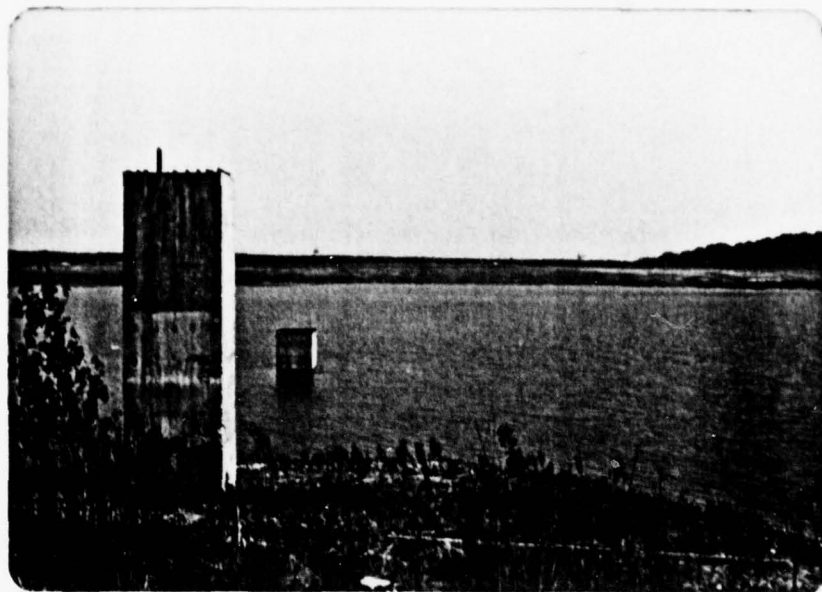
Reservoir with decant towers.  
Dam in background

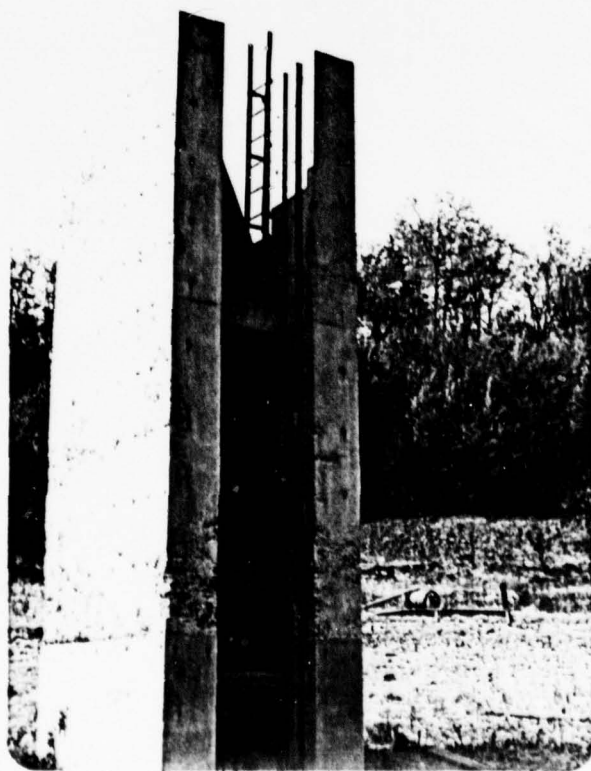
the drain pipe. All structures appeared to be in good condition. A boat would be required to inspect the tower located in the reservoir. The owner's representative stated that a standpipe was located in this tower on the decant line. The inflow elevation is unknown.

Detail of Decant Tower

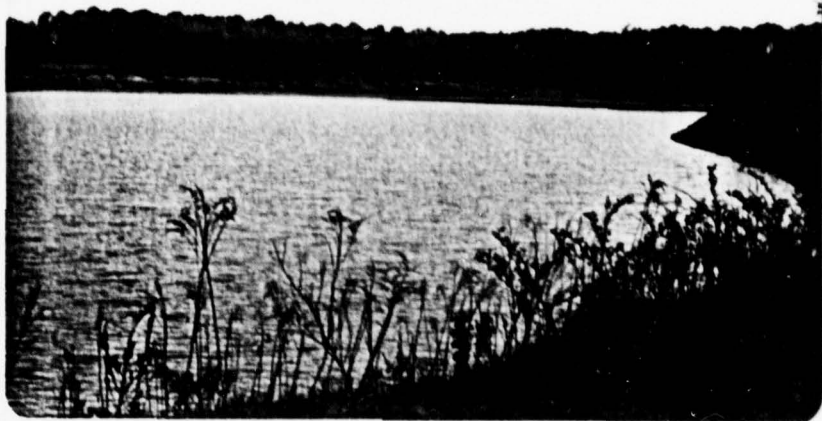
Reservoir - Dam in background

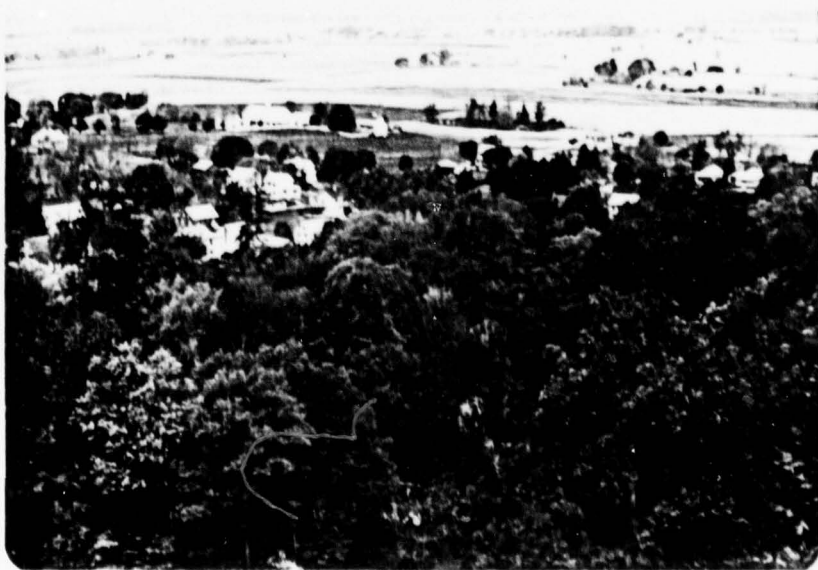
The downstream channel is the natural stream (Bernhard Creek) with several houses close to the stream and close to the embankment fill. About 2,000 feet downstream from the dam, the stream runs through the town of Rexmont with several homes located close to the stream. If the dam would fail due to overtopping, it is expected that the hazard to loss of life would increase. The hazard category for this dam is considered to be "High".

Looking downstream from top of dam
